Manhole Inspection Summary

Manhole # S13Q__011MH

Insp Date: **12/31/08 1:01 PM**

Location Address: **2819 Wilkens ave**

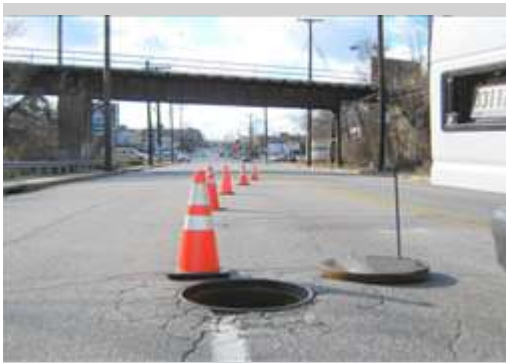
Location View

facing west on Wilkens Ave

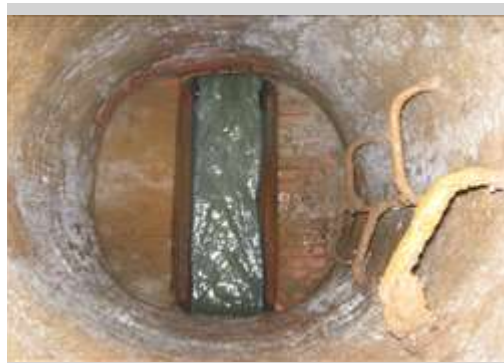
Top View

mh cover

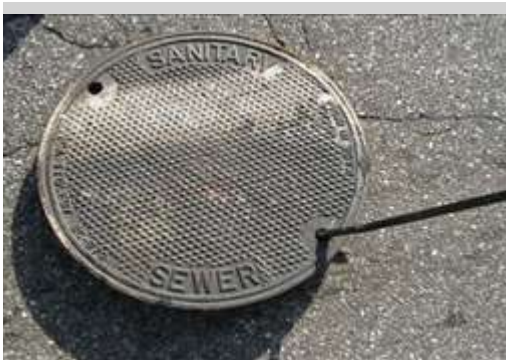
mh cover

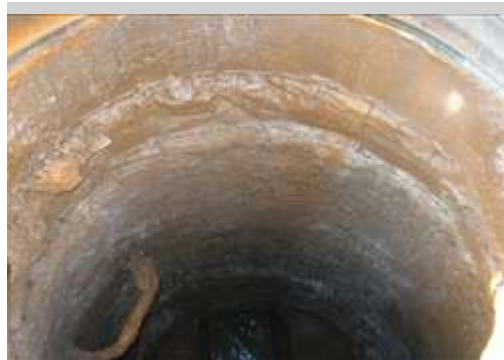
Defect 6

Condition: ☐ Sound ☐ Cracked ☐ Root Intrusion ☒ **Loose Brick** ☐ Deteriorated

Infiltration: ☐ None ☐ Joint ☐ Cracks ☐ Mortar ☐ Roots ☒ **Wall**

loose bricks and cracked mortar under chinmey with infiltration

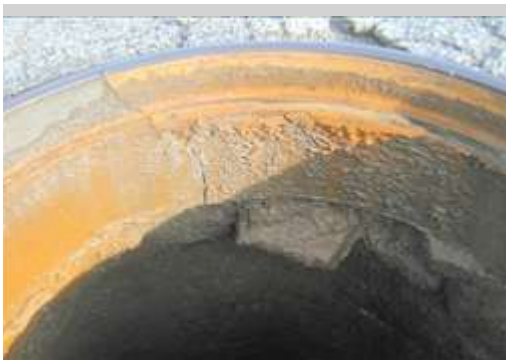
Defect 4

Frame Offset: **0** (in.) Condition: ☐ Sound ☒ **Cracked** ☒ **Leaks**

infiltration from top
cracked frame

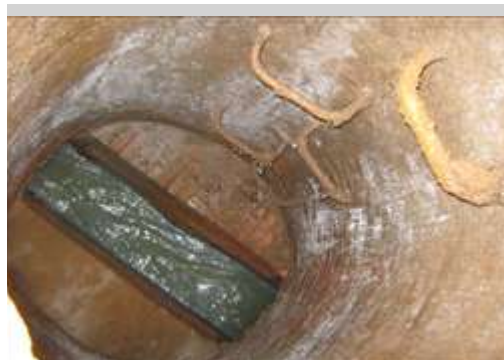
Defect 3

Steps Count: **5** Missing: **0** ☒ **Corroded**

corroded rungs

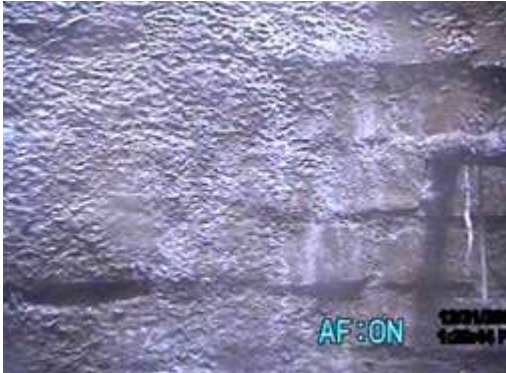
Defect 2

Infiltration: ☐ None ☐ Joint ☐ Cracks ☐ Mortar ☐ Roots ☒ **Wall**

deposits on corbel wall with infiltration

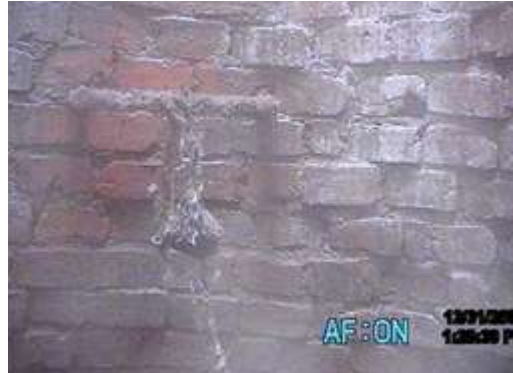
Defect 1

Surcharge ☒ **Evidence Of Surcharge** Depth: **4** (ft.) ☐ Active Surcharge Present

evidence of surcharge @ 4ft

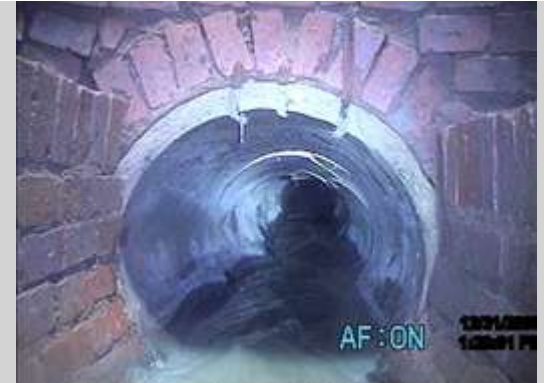
12 O'Clock Outflow

18 in. Circular Gravity Sewer
Pipe Out @ 12 O'Clock

Pipe Height: **18** (in.) Rod and Bar (Angled)
Pipe Material: **Clay** ☐ Pipe Lined
Invert Depth: **10.60** (ft.) Flow Characteristics: **Fast**
Deposits: ☒ None ☐ Mud ☐ Sludge ☐ Debris ☐ Grease
Silt Depth: **0** (in.) Deposits Extent:
Infiltration: **None** Pipe Seal Cond: **Sound**

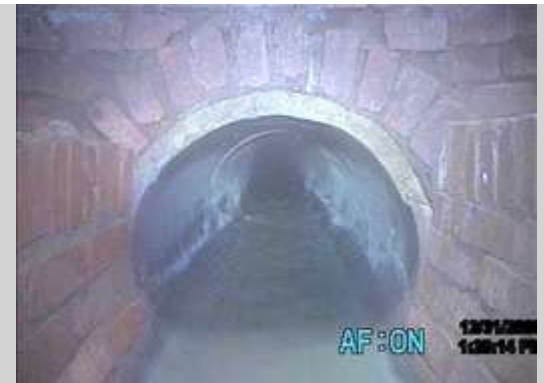
6 O'Clock Inflow

18 in. Circular Gravity Sewer
Pipe In @ 6 O'Clock

Pipe Height: **18** (in.) Rod and Bar (Angled)
Pipe Material: **Clay** ☐ Pipe Lined
Invert Depth: **10.50** (ft.) Flow Characteristics: **Fast**
Deposits: ☒ None ☐ Mud ☐ Sludge ☐ Debris ☐ Grease
Silt Depth: **0** (in.) Deposits Extent:
Infiltration: **None** Pipe Seal Cond: **Sound**
